**Maryland Historical Trust
State Historic Sites Inventory Form**

Survey No. CARR-1379

historic John W. Davis Farm

street & number 4780 Piney Creek Road not for publication

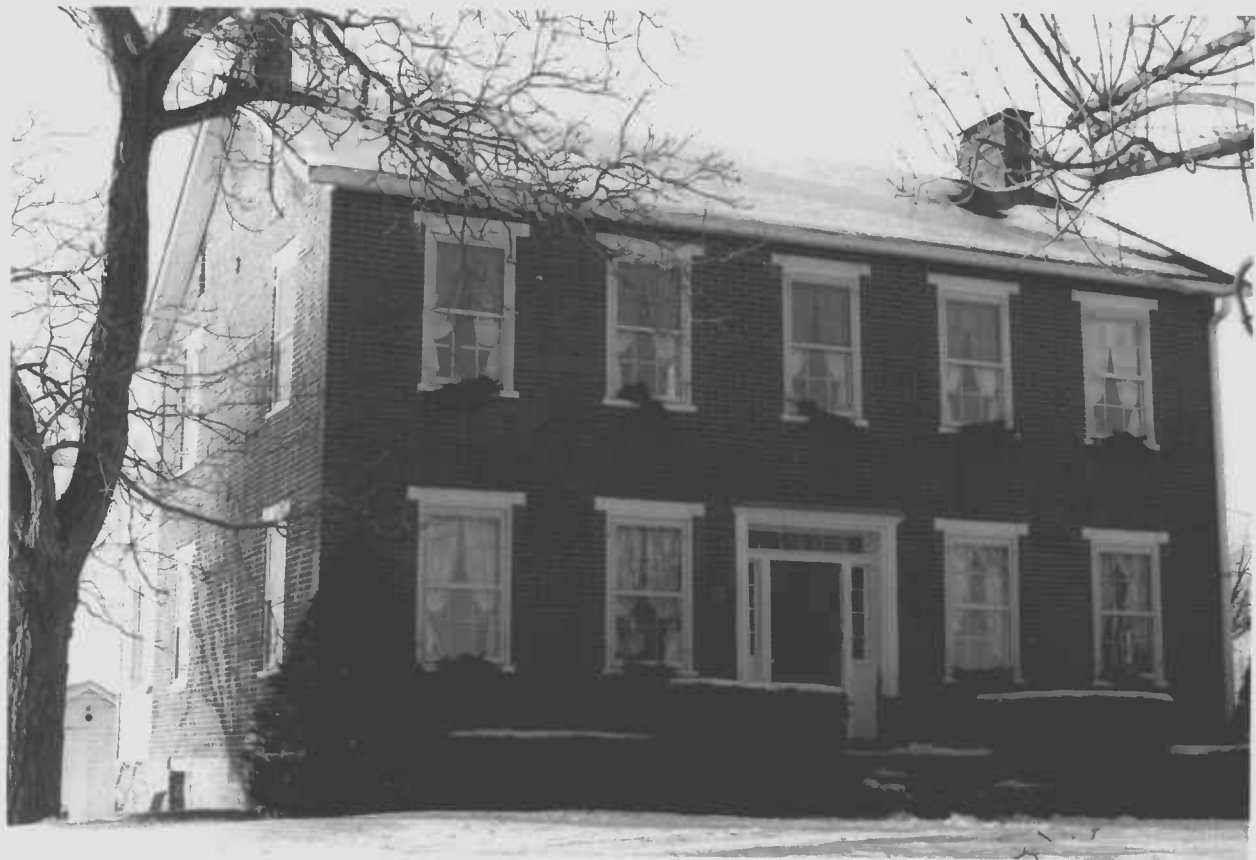
John W. Davis Farm
4780 Piney Creek Rd.
Carroll County, Maryland
Photo: Kenneth M. Short
Date: January 1994
Neg. Loc.: Maryland Historical Trust
House - SW & SE elevations
1/4

The house faces southeast, toward the road, and is a five-bay by two-bay, two-story structure. It has a rubble stone foundation, stretcher bond brick on the southeast elevation, and 6-1 common bond brick elsewhere. The brick has been sandblasted and the mortar joints were cut out with a saw and repointed. According to the owner, the house had been painted and striped before they did this work. The gable roof has asphalt shingles and a northeast-southwest ridge. There is a rebuilt interior brick chimney on each gable end. The southeast elevation has a 6/6 sash in the east bay of the foundation. The ground level appears to have been raised, as the window now sits in

The southwest elevation has two openings in the foundation with wood lintels and corner blocks. The south bay has a vent with wood louvers that are diamond in section and are now covered by a new window. The frame of the vent has a beaded interior edge. The west bay has a metal grate that slides back into the wall, and behind it a six-light sash that has been cut down to fit the opening. There are two 6/6 sash on both the first and second stories and two four-light sash in the gable end. The latter have beaded interior-edge frames, wood sills, and no lintels. There are two star anchors centered on the wall, one at the second floor level and one at the attic floor.

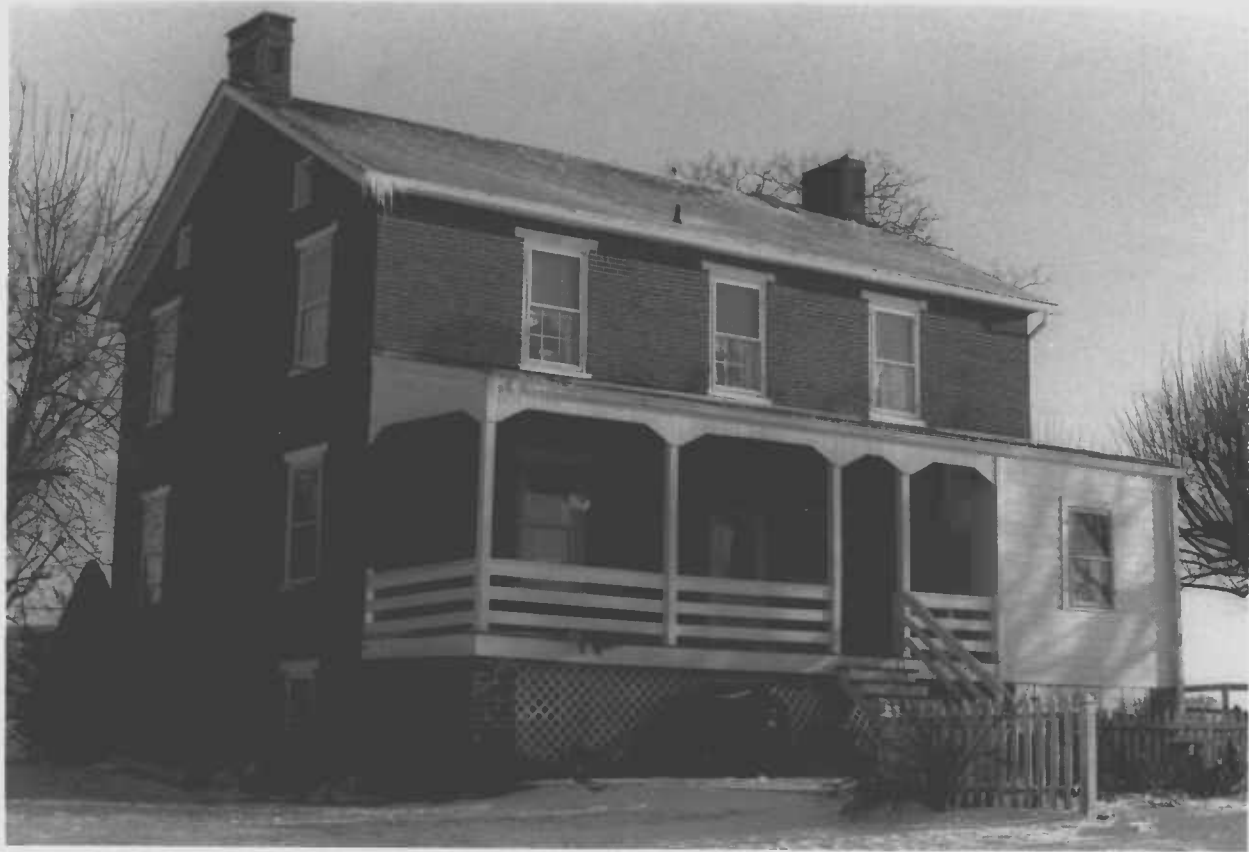
2/4

House - NE & NW elevations

The northwest elevation is three bays. The first story has a 6/6 sash to the north. There is a door in the center bay with four lights over two panels and a three-light transom. The frame has a beaded interior edge and the wood lintel has plain corner blocks. Between the center and west bays are a pair of more recent six-light casements. There is a one-story, shed roof porch that has been rebuilt. The west bay of the porch has been enclosed with German siding. The southwest and northwest elevations of this enclosure have a 6/6 sash with a beaded interior-edge frame and shutter hardware. The northeast elevation has a four-panel door. The rubble stone cheek wall on the southwest end of the porch is tied into the house foundation. There is also a stone wall between the center and west bays, under the northeast wall of the enclosure. The stone wall under the northeast elevation of the porch is also tied into the house, and has a beaded-edge vertical-board door set into it. The second story has three 6/6 sash and there is a brick dentil course and box cornice above it.

The northeast elevation has two 6/6 in the foundation, first, and second stories, and two four-light sash in the gable end like those on the southwest. There are also two star anchors centered on the ridge, at the second story and attic floor levels.

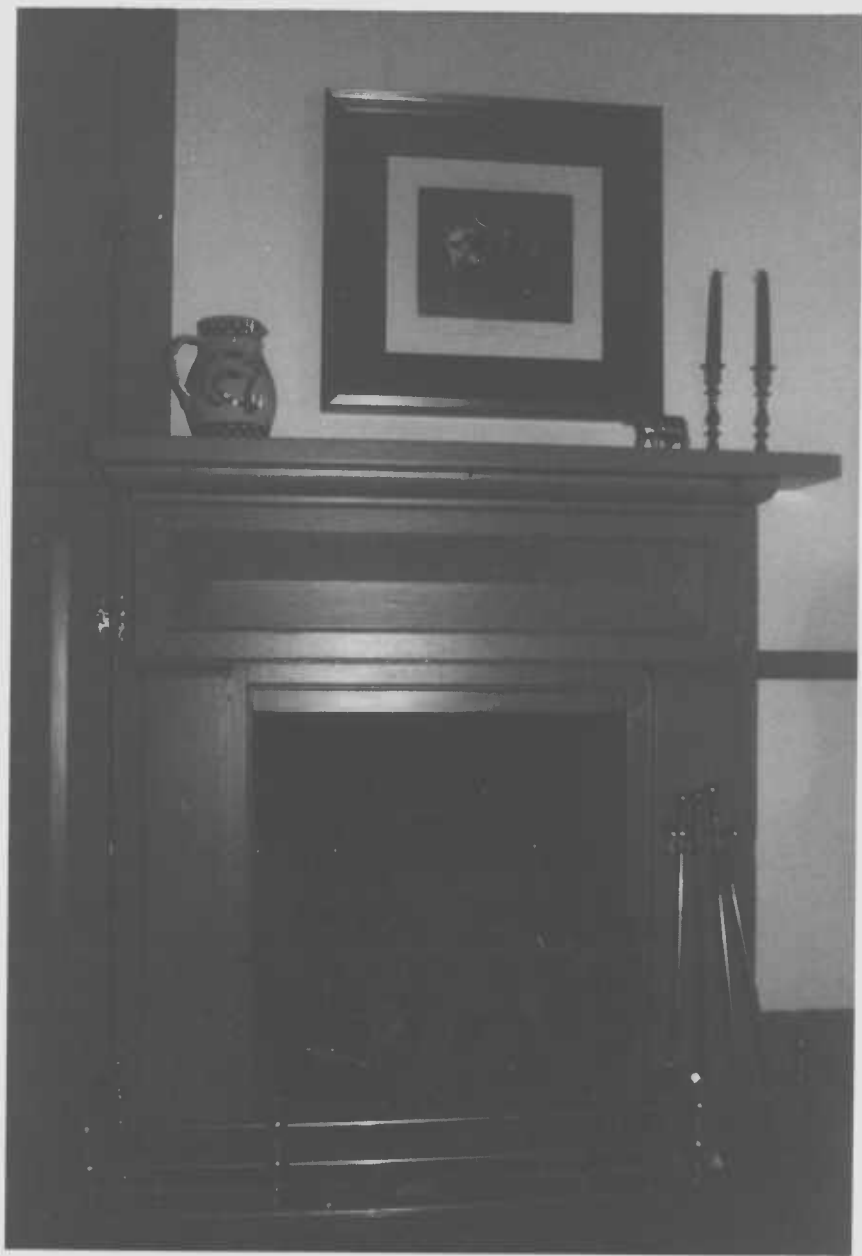
$\frac{3}{4}$

Neg. Loc.: Maryland Historical Trust
east room fireplace

The east room is deep and has two doorways on the southwest wall, one to the south from the passage and one to the west from the west room. There was originally a doorway centered on the northwest wall, but this has been closed off. The door surrounds are wide and plain, with an ogee moulding across the top. The windows have plain splayed jambs. There is a fireplace centered on the northeast wall. The wood mantel has pilaster strips, a frieze with a beaded interior edge and a raised pyramidal panel, and a bed mould that has two ovolos. North of the fireplace is a closet with one door over a single door. The doors are new, but according to the owner, originally

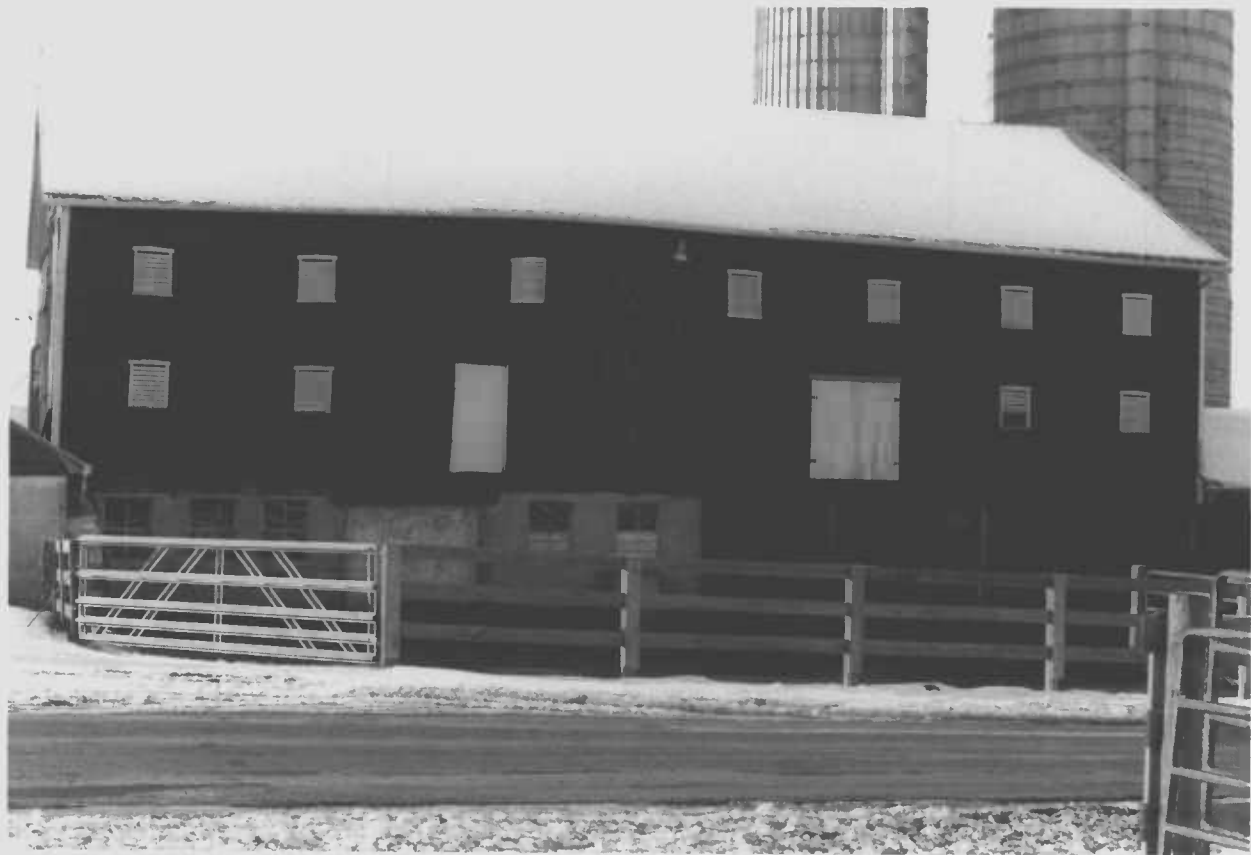
4/4

Barn - SE elevation

There is a bank barn about 100 feet northeast of the house. The forebay faces southeast. In reality, the ground is flat, and earth has been pushed up on the northwest to create a bridge or ramp to the upper story. The lower story has rubble fieldstone, the upper has vertical-board siding on three sides, and the gable roof has inverted-V-seam metal and a northeast-southwest ridge. The northwest elevation has two pair of wagon doors on rollers on the upper story, with two six-light sash to the west. The southeast elevation has been largely rebuilt on the lower story with CMU's and metal sash for a dairy operation. There is a beaded-edge vertical-board door to the west. The upper story has a vertical-board door on strap hinges to the west, and three small wood-louver vents, with four vents above them, two vents in the gable end and a large vent in the peak. There is a CMU milkhouse attached to the south corner. The northeast elevation has new structures attached to the lower story, and the upper story is identical to that on the southwest, but without the door.

The southeast elevation has CMU's on the south half of the lower story. The east half has a horizontal board wall with, from south to east, a door, four one-light sash, another door, a one-light sash, a new opening, and a one-light sash. The doors are vertical-board dutch doors on strap hinges. The upper story has horizontal-board siding on this elevation only. From south to east there is a pair of wood-louvered vents above another pair of vents, a vertical-board door on strap hinges, a vent set up high, a beaded-edge vertical-board door on rollers, another vent set high, double-vertical board doors with a vent above them, and a pair of vents over another pair of vents.
